Office-Shop

Review conducted January 2012 using 2010 ADA Standards for Accessible Design.

Areas of Non-Compliance & Recommendations

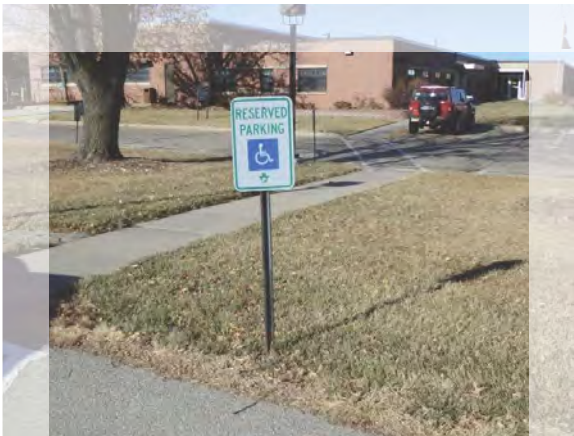
Image 1

0-001 Signs identifying accessible parking spaces in parking lot and along south side of building mounted too low. Signage at accessible parking spaces must be a minimum of 60 inches above the ground to the bottom of the sign. [ADA Sections 216.5, 502.6, and 703.7.2.1] (See Images 1 and 2).

- 0-002 No designated van accessible parking space identified. For every six (or fraction of six) accessible parking spaces required, at least one shall be designated as van parking with an 11'-0" space and 5'-0" access aisle (or 8'-0" space and 8'-0" access aisle). A sign identifying the space as large enough to park a van must be mounted 60 inches minimum above the ground surface measured to the bottom of the sign. [ADA Sections 208.2.4, 216.5, and 502.6] (See Images 1 and 2).

» Recommendation: Remount signs to required height.

» *Recommendations: Add a sign to the bottom of the sign in front of the spaces on the south side of the building identifying them as "van accessible."*

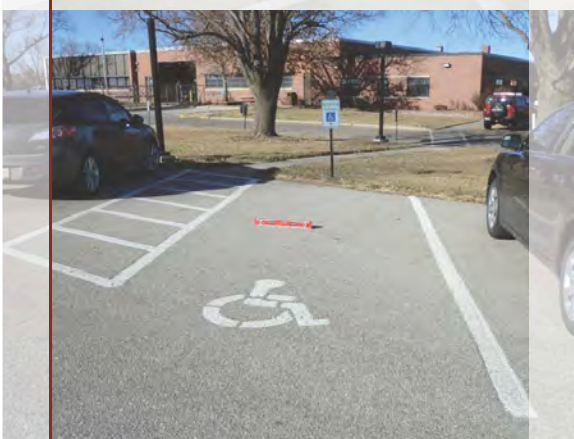
Image 3

- 0-003 Cross slope of accessible parking space in parking lot greater than allowed by ADA Design Standards (3.0%). Parking spaces and access aisles serving them are not permitted to have slopes/cross slopes steeper than 1:48 (2%). [ADA Section 502.4] (See Image 3).

» *Recommendations: Resurface parking space so that cross slope meets ADA requirements of 1:48.*

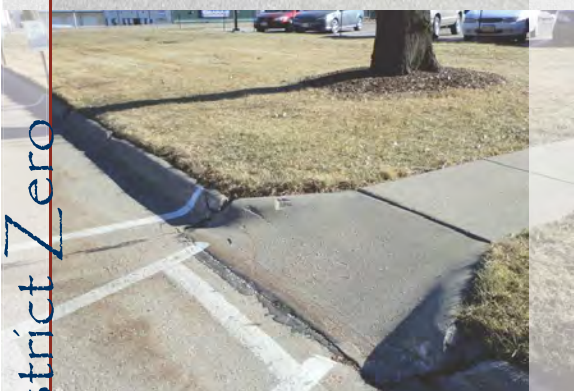
Image 4

- 0-004 Slope of ramp on north end of sidewalk leading from access aisle at parking space in parking lot to driveway greater than allowed (18.7%). In existing sites, ramps shall be permitted to have running slopes up to 1:10 where such slopes are necessary due to space limitations. Otherwise, curb ramps shall have a running slope no steeper than 1:12. [ADA Section 405.2] (See Image 4).

» *Recommendations: Remove and replace curb ramp so that it meets ADA Design Standards.*

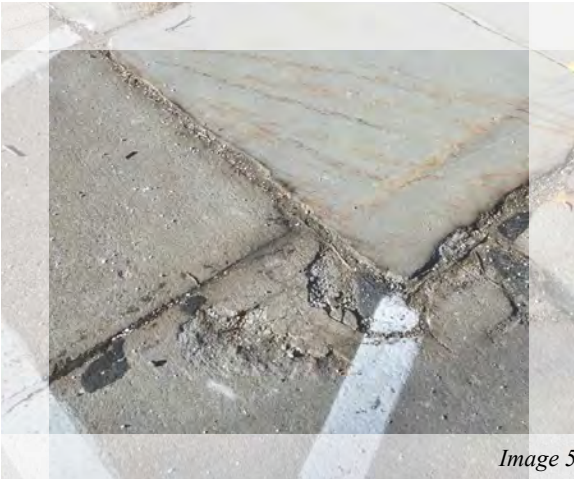
- 0-005 Transition between driveway and curb ramp at sidewalk leading to public entrance greater than allowed by ADA Design Standards. Changes in level between 1/4 inch high minimum and 1/2 inch high maximum shall be beveled with a slope not steeper than 1:2. [ADA Section 303.3] (See Image 5 on page 4).

» *Recommendations: Grind concrete at transition to create beveled lip at entrance to curb ramp.*

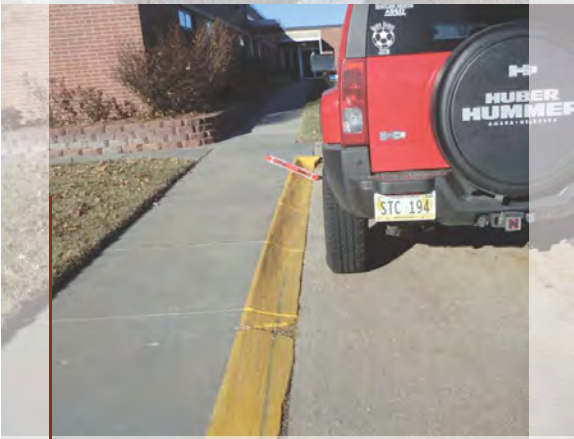
- 0-006 Flares on side of curb ramp at sidewalk leading to public entrance steeper than allowed by ADA Design Standards (48%). Where provided, curb ramp flares shall not be steeper than 1:10 (10%). [ADA Section 406.3] (See Image 6 on page 4).

» *Recommendations:
Remove flared edge.*

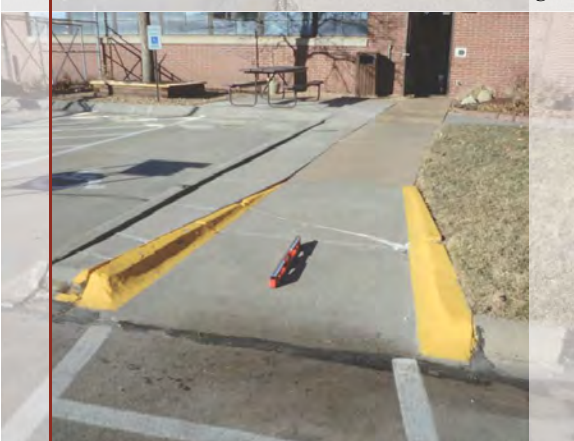
Image 7

- 0-007 Slope of curb ramp and cross slope of sidewalk running parallel to the accessible parking spaces on the south side of the building greater than allowed by ADA Design Standards (11%). In existing sites, ramps shall be permitted to have running slopes up to 1:10 (10%) where such slopes are necessary due to space limitations. Otherwise, curb ramps shall have a running slope no steeper than 1:12 (8.33%). Cross slope shall be no steeper than 1:48. [ADA Section 405] (See Image 7).

- 0-008 Broken surface on curb ramp at sidewalk running parallel to the accessible parking spaces on the south side of the building hinders stable and firm accessible route. Disabled visitors may lose balance or be unable to maneuver mobility aids due to changes in elevation and uneven surfaces. [ADA Sections 206, 302, and 402] (See Image 7).

- 0-009 No level landings at tops of curb ramps. Landings must be provided at the tops of curb ramps with a clear width at least as wide as the curb ramp, excluding flared sides. [ADA Section 406.4] (See Images 7 and 8).

Remove and replace curb ramp so that it meets ADA Design Standards.

Repair or replace areas of sidewalk that are not at 1:48 cross slope (approx. 8 linear feet).

» *Recommendation: Remove and replace curb ramp.*

» *Recommendation: Install level landings at top of curb ramp.*

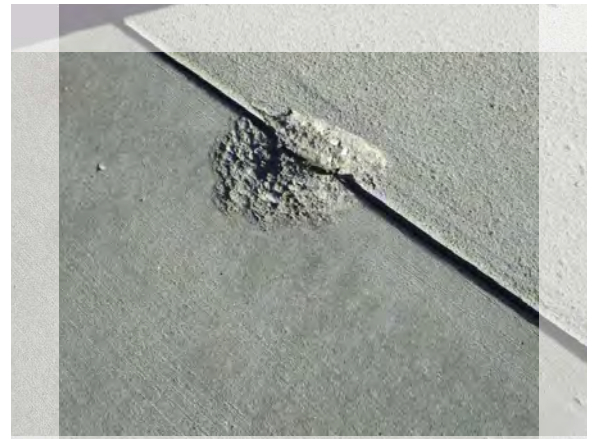
Image 9

- 0-010 Broken surface and holes on sidewalk leading to public entrance of building hinders stable and firm accessible route. Disabled visitors may lose balance or be unable to maneuver mobility aids due to changes in elevation and uneven surfaces. [ADA Sections 206, 302, and 402] (See Images 9 and 10).

» *Recommendation: Patch and repair sidewalk.*

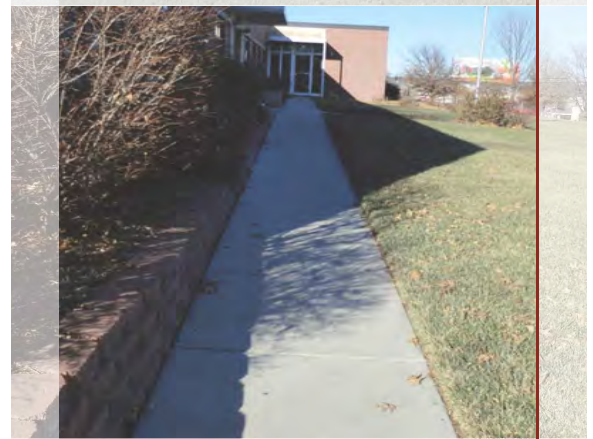
Image 11

of greater than 1:48 can impede forward progress and compromise control and balance. [ADA Section 403.3] (See Image 11).

» *Recommendation: Remove and replace areas of sidewalks so that cross slopes are 1:48 or less (approximately 100 square feet).*

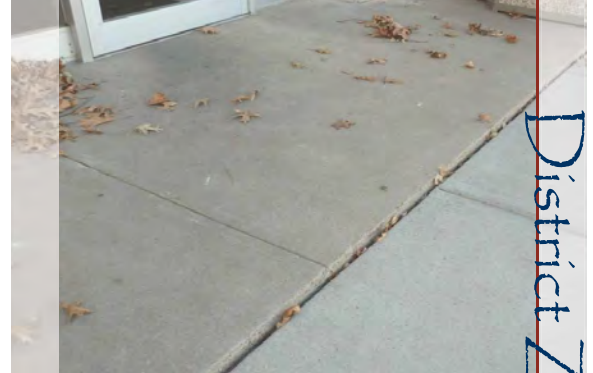
Image 12

- 0-012 Change in level greater than 1/2 inch at transition between sidewalk and landing at public entrance door. Changes in level of 1/4 inch high maximum shall be permitted to be vertical. Changes in level between 1/4 inch high minimum and 1/2 inch high maximum shall be beveled with a slope not steeper than 1:2. [ADA Section 303] (See Image 12).

» *Recommendation: Grind concrete to create beveled transition at entrance door landing.*

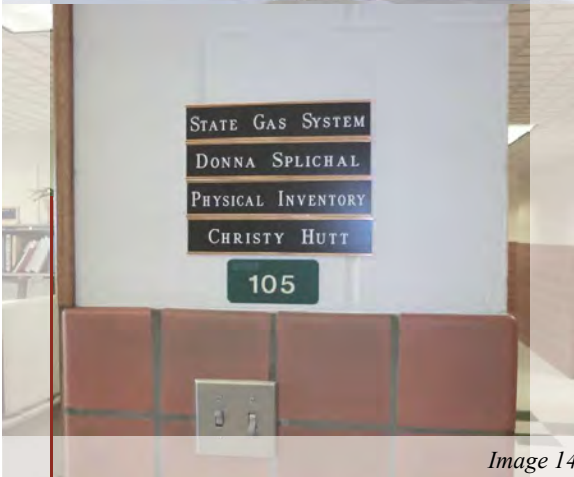
Image 14

- 0-014 Signage throughout accessible route non-compliant in mounting height and type. Signs that provide designations, labels, direction to or information about interior spaces, or names for interior rooms or spaces where the sign is not likely to change over time (such as signs for restrooms, room and floor numbers or letters, and room names) require Braille and tactile lettering to comply with ADA standards. Signs shall be located on the wall or on the latch side of the door 48 inches above the finished floor measured from the baseline of the lowest tactile character to 60 inches measured from the baseline of the highest tactile character. Braille shall be positioned below the corresponding text. [ADA Sections 216.2 and 703] (See Images 14 and 15).

» *Recommendation: Provide signs that meet criteria with braille and tactile characters and install at height and location required.*

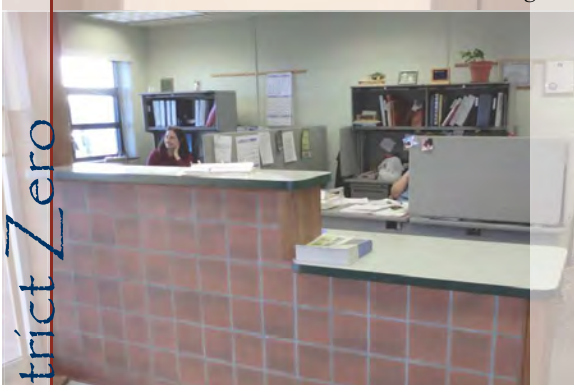
Image 16

- 0-016 Access to sign-in book on top of service counter at reception area 105 above allowed reach range. Where a clear floor space requires a reach over an obstruction, the height of the obstruction shall be 34 inches maximum. The height of the counter on which sign-in book is placed is 45 inches a.f.f. [ADA Section 308] (See Image 16).

» *Recommendation: Place sign-in book on lower counter top.*

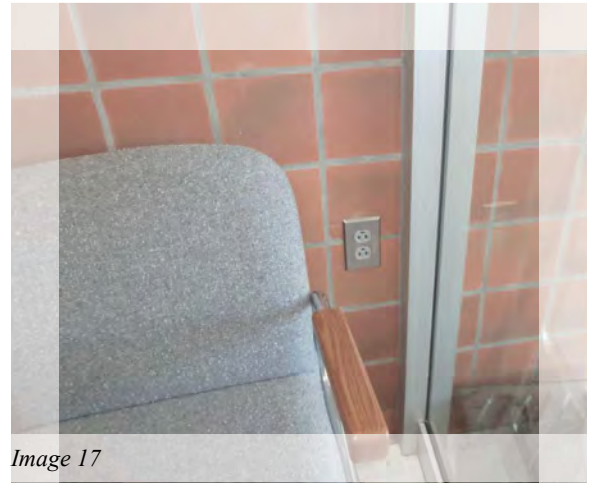
Image 17

- 0-017 Access to electrical outlet in lobby area at reception area 105 blocked by placement of chair. A minimum of 30 inches by 48 inches of clear floor space is required in front of all elements for a forward or parallel approach. [ADA Section 305.3] (See Image 17).

» *Recommendation: Relocate chair to allow clear floor space in front of outlet.*

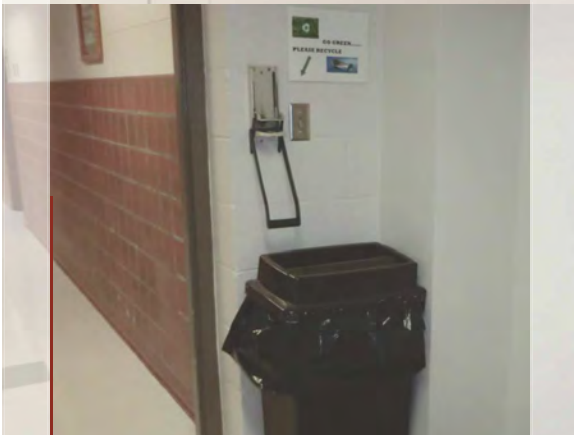
Image 22

- 0-021 Access to aluminum can crusher near storage closet 140 above allowed reach range (50 inches to bottom of element). Where a clear floor space requires an obstructed reach to an object, the high side reach shall be 48 inches maximum for a reach depth of 10 inches maximum. [ADA Section 308.3.2] (See Image 22). ⚓

» *Recommendation: Lower can crusher so that reach to highest operable part is no greater than 48 inches a.f.f.*

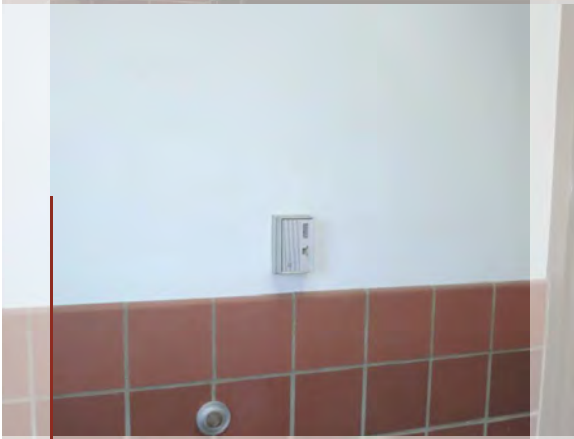
Image 30

- 0-030 Thermostat control mechanism in east exit vestibule (near office space 131) above allowed reach range (53 inches a.f.f.). Controls are measured to highest operating mechanism. [ADA Sections 308] (See Image 30). ⚓
- » *Recommendation: Lower thermostat so that highest operating mechanism is no more than 48 inches above finished floor.*

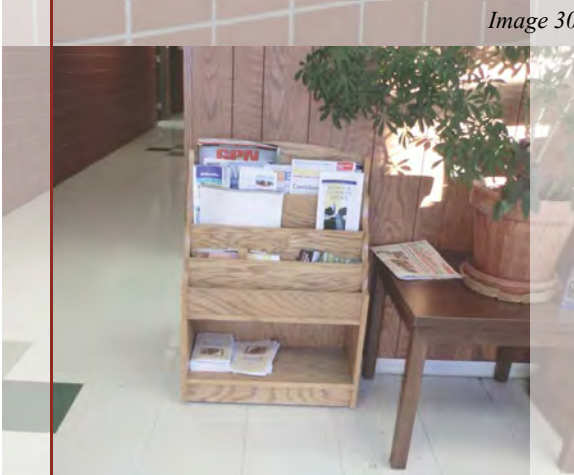
Image 31

- 0-031 Access to literature display in reception area 123 below allowed reach range (4 inches to bottom shelf). Where a clear floor space allows a parallel approach to an element and the side reach is unobstructed, the high side reach shall be 48 inches maximum, and the low side reach shall be 15 inches minimum above the finished floor. [ADA Section 308] (See Image 31).
- » *Recommendations: Relocate telephone directories so that no reach to bottom shelf is necessary.*

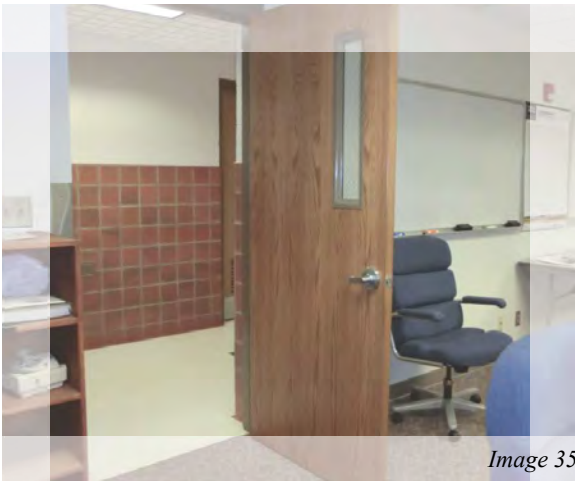
Image 35

- 0-037 Glazed panel located too high in door (50 inches a.f.f.). Doors containing glazing panels that permit viewing must be located in the door so that the bottom of the glazed panel is no more than 43 inches above the finished floor. [ADA Section 404.2.11] (See Image 35). ⚓

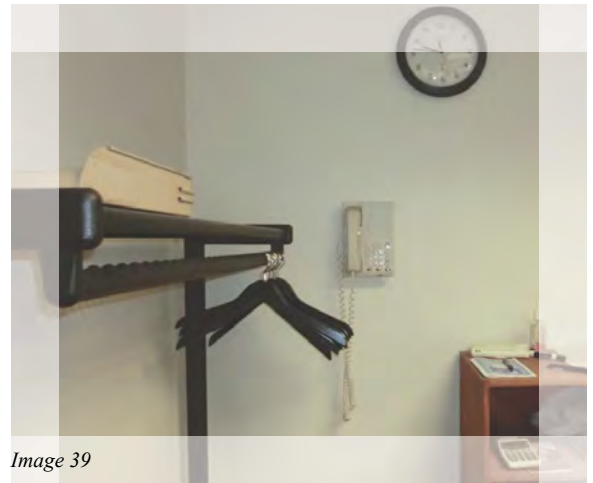
Image 39

- 0-043 Telephone in conference room mounted above allowed reach range. Reach measured 59-1/8 inches above finished floor to the centerline of the top row of keypad. [ADA Section 308] (See Image 39).

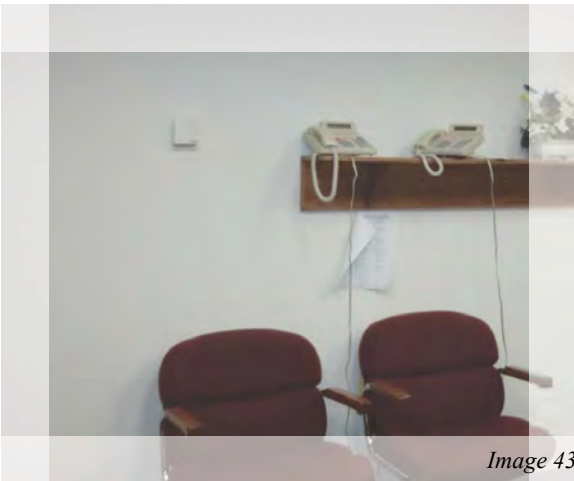
Image 43

- 0-047 Thermostat control mechanism above allowed reach range and blocked by chair (59-1/2 inches a.f.f.). Controls are measured to highest operating mechanism. A clear floor space of 30 inches by 48 inches is required in front of all elements. [ADA Sections 308] (See Image 43).

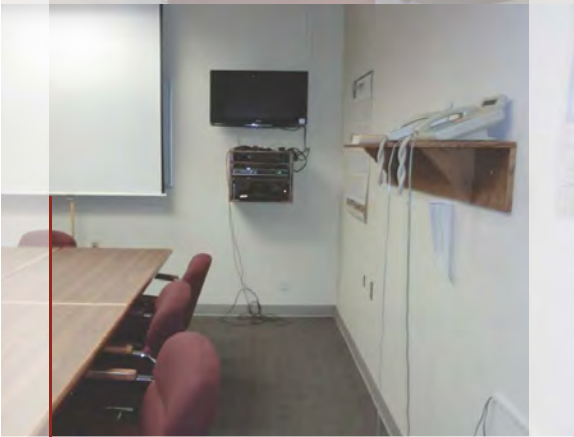
Image 44

- 0-048 Wall shelves mounted above reach range and create protrusions. Shelves shall be located within the reach range of 15 inches to 48 inches above the finished floor. Objects with leading edges more than 27 inches and not more than 80 inches above the finished floor shall not protrude more than 4 inches horizontally within the clear floor space. When a cane is used and the element is not in the detectable range, insufficient time is available for the person to detect the element with the cane before there is body contact. [ADA Sections 225.2 and 307.2] (See Images 43 and 44).

- 0-049 Access to AV equipment above allowed reach range (56-1/8 inches to top of shelving unit) and creates protrusion. Shelves shall be located within the reach range of 15 inches to 48 inches above the finished floor. Objects with leading edges more than 27 inches and not more than 80 inches above the finished floor shall not protrude more than 4 inches horizontally within the clear floor space. When a cane is used and the element is not in the detectable range, insufficient time is available for the person to detect the element with the cane before there is body contact. [ADA Section 225.2 and 308] (See Image 44).

If shelves are mounted above 27 inches a.f.f., provide barrier(s) below full length of shelves to act as detectable object(s).

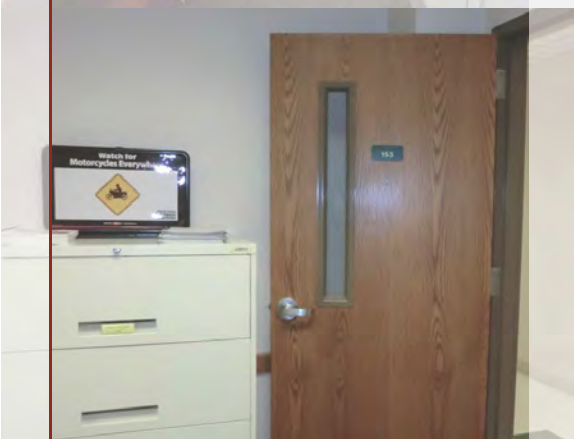
Image 45

- Room number placed on door rather than wall on latch side of door. [ADA Section 703.4.2] (See Images 45 and 46).
- Inadequate maneuvering clearances at both entrance doors due to placement of furniture and stored items. [ADA Section 404.2.4.2] (See Images 45 and 46).
- Restricted access to aisle between cubicles due to placement of furniture (28 inches). [ADA Sections 402 and 403] (See Image 47).
- Restricted access into cubicles due to placement of cubicle walls and furniture. [ADA Section 404.2.3] (See Image 48).

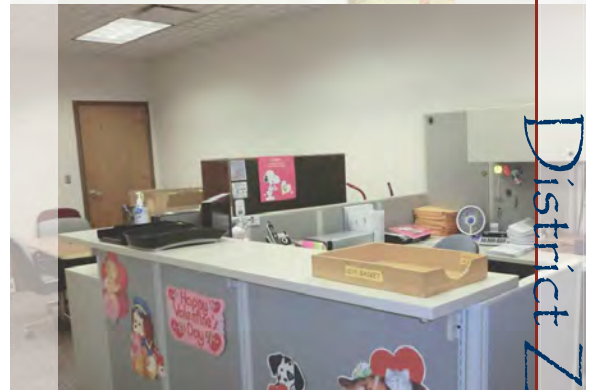
- 0-052 Service counter in reception area above allowed height (42-1/4 inches a.f.f.). A portion of any service counter must be accessible to someone in a seated position for either a forward or side approach. [ADA Section 904.4.1] (See Image 50 on page 15).

» *Recommendation: Provide a minimum 36 inch long portion of the service desk at 36 inches or lower above finished floor.*

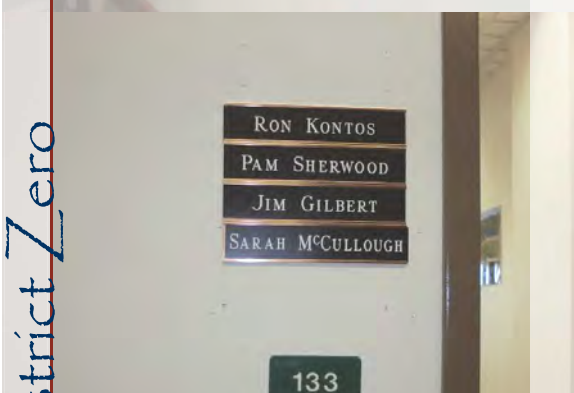
Image 62

Braille shall be positioned below the corresponding text. [ADA Sections 216.2 and 703] (See Image 62).

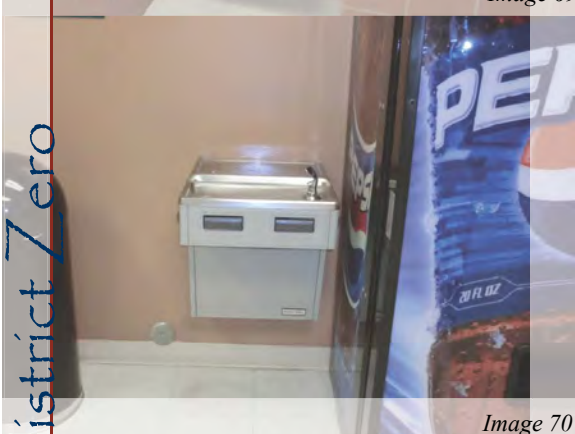
Image 70

- 0-071 Clear floor space at drinking fountain in vending area not centered on unit. Units shall have a clear floor space of 30 inches by 48 inches positioned for a forward approach and centered on the unit. Knee and toe clearance shall be provided. [ADA Section 602.2] (See Image 70).

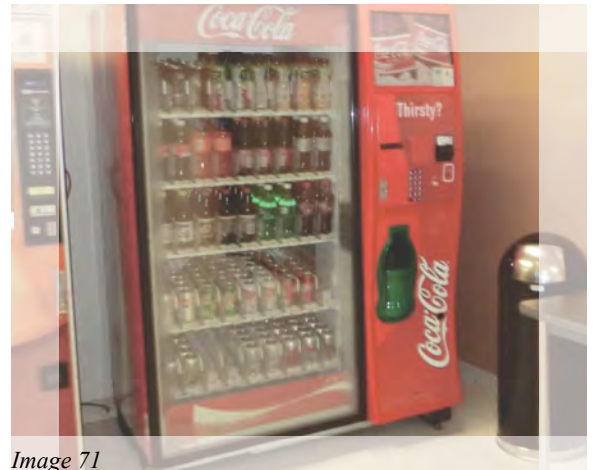
Image 71

- 0-072 Highest operable part of Coca-cola vending machine above allowed reach range (48-1/2 inches a.f.f. to bill changer). Where provided, at least one vending machine of each type shall comply with ADA guidelines. [ADA Sections 228.1 and 309] (See Image 71). ⚓

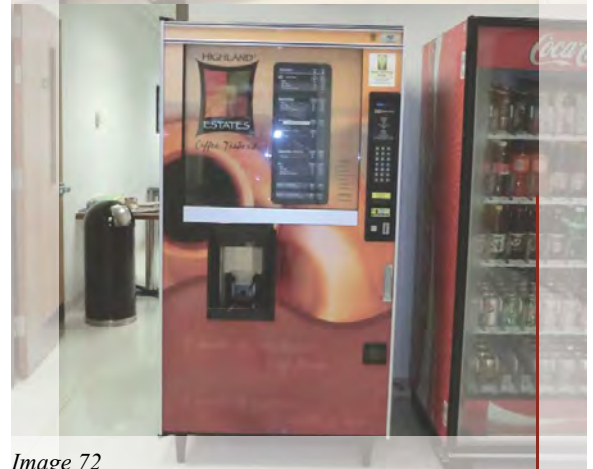
Image 72

- 0-073 Highest operable part of coffee vending machine above allowed reach range (53-1/4 inches a.f.f. to top row of keypad). Where provided, at least one vending machine of each type shall comply with ADA standards. [ADA Sections 228.1 and 309] (See Image 72). ⚓

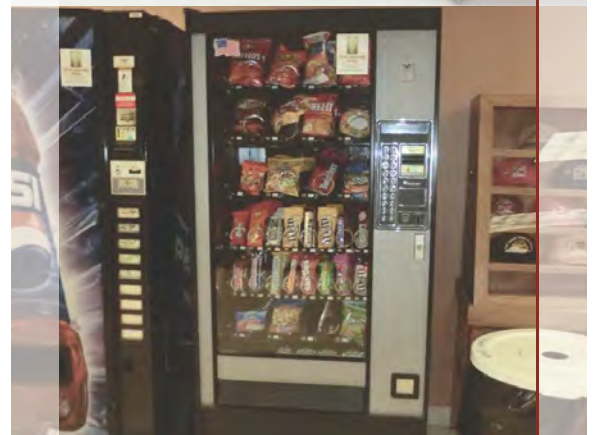
Image 73

- 0-074 Highest operable part of snack vending machine above allowed reach range (54-3/8 inches a.f.f. to top row of keypad). Where provided, at least one vending machine of each type shall comply with ADA standards. [ADA Sections 228.1 and 309] (See Image 73).

Remove vending machine from public access area.

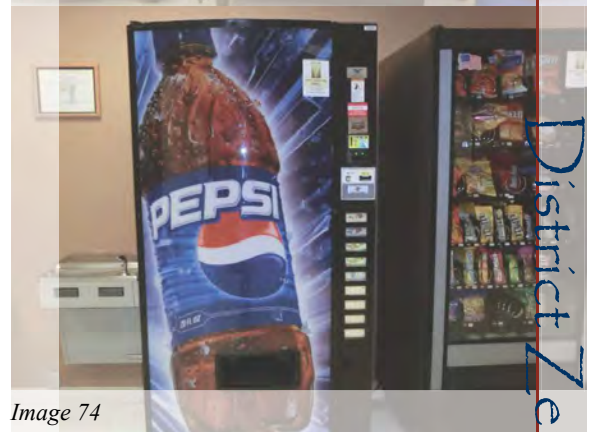
- 0-075 Highest operable part of Pepsi-cola vending machine above allowed reach range (53-1/4 inches a.f.f. to bill changer). Where provided, at least one vending machine of each type shall comply with ADA standards. [ADA Sections 228.1 and 309] (See Image 74 on page 21).

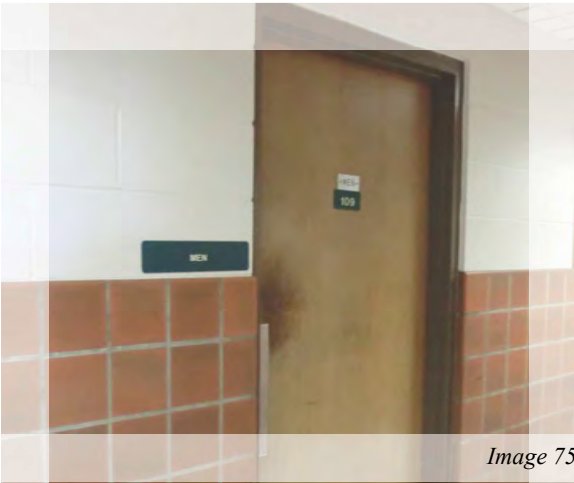
Image 75

- 0-076 Braille on restroom identification sign placed in wrong location. Braille shall be positioned below the corresponding text. [ADA Section 703.3.2] (See Image 75).

- 0-077 Room number mounted on door above allowed height. When space allows, signs are to be located alongside the door at the latch side between 48 and 60 inches a.f.f. measured to the baseline of the tactile characters. [ADA Section 703.4.2] (See Image 75).

- 0-078 No signage directing users to accessible restroom. Where existing toilet rooms do not comply with ADA Design Standards, directional signs indicating the location of the nearest accessible toilet room within the facility shall be provided. [ADA Section 216.8] (See Image 75).

» *Recommendation: Install sign providing direction to accessible toilet room.*

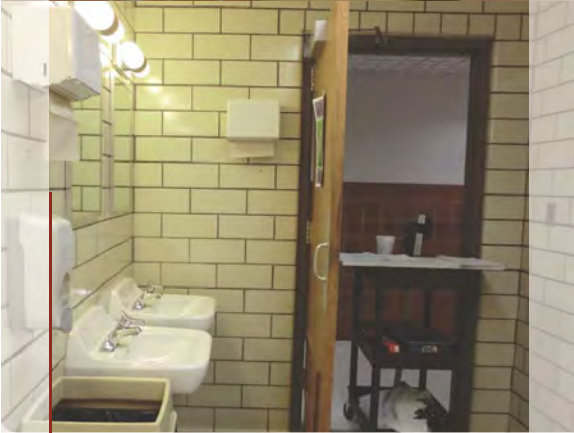
Image 76

- 0-080 Inadequate maneuverability clearance space available on pull side of entrance door (11-1/4 inches). Minimum front maneuvering clearance necessary to pull open a door that has a closer is 18 inches. [ADA Section 404.2.4] (See Image 76).

- 0-081 Light switch mounted above allowed reach range (50-1/4 inches a.f.f.). The high side reach shall be 48 inches maximum, and the low side reach shall be 15 inches minimum above the finished floor. [ADA Section 308] (See Image 76). ⚓

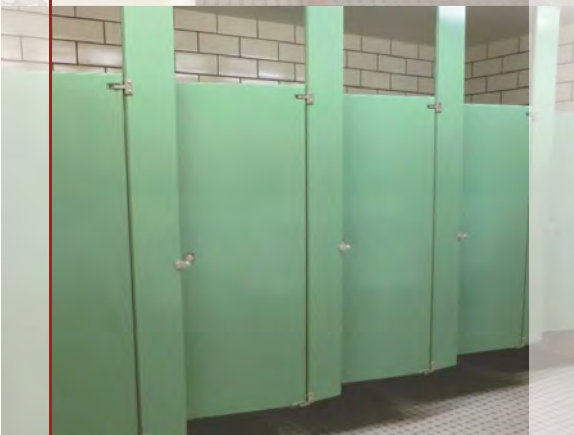
Image 77

- 0-082 No accessible toilet stall available. Where toilet compartments are provided, at least one toilet compartment shall comply with ADA Design Standards for size, grab bars, toilet seat height and location, toilet paper dispenser, clear floor space, and door requirements. All modifications must meet local administrative authority code requirements. [ADA Section 213.3.1] (See Image 77).

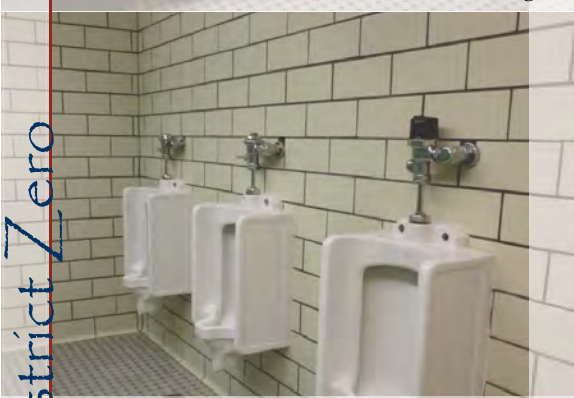
Image 78

- 0-083 No accessible urinal provided. Where more than one urinal is provided, at least one shall comply with ADA Design Standards including mounting height, urinal depth and flush force, and control height. [ADA Sections 213.3.3, 605.2, and 605.4] (See Image 78).

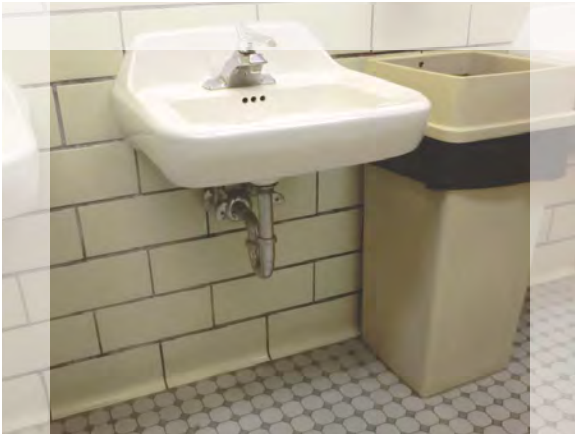
- 0-084 No pipe protection provided under lavatory. Water supply and drain pipes under lavatories must be insulated or otherwise configured to protect against contact. [ADA Section 606.5] (See Image 79 on page 24).

- 0-085 Force to operate lavatory faucet greater than 5 pounds. The force required to activate operable parts shall be 5 pounds maximum. [ADA Sections 309.4 and 606.4] (See Image 79).

» *Recommendations: Wrap pipes of at least one lavatory with insulating material.*

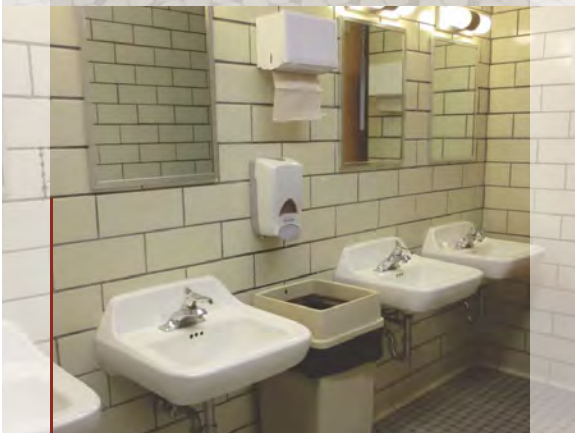
Image 80

- 0-086 Mirror mounted above allowed height measured to bottom edge of reflecting surface not bottom edge of mirror (49-1/2 inches a.f.f.). Mirrors located above lavatories or countertops shall be installed with the bottom edge of the reflecting surface 40 inches maximum above the finished floor. [ADA Section 603.3] (See Image 80).

- 0-087 Outlet to paper towel dispenser above allowed reach range and blocked by garbage can (63-1/2 inches a.f.f.). Where a clear floor space requires an obstructed parallel approach to an element, the high side reach shall be 46 inches maximum for a reach depth of 24 inches maximum. [ADA Section 308] (See Images 80 and 81).

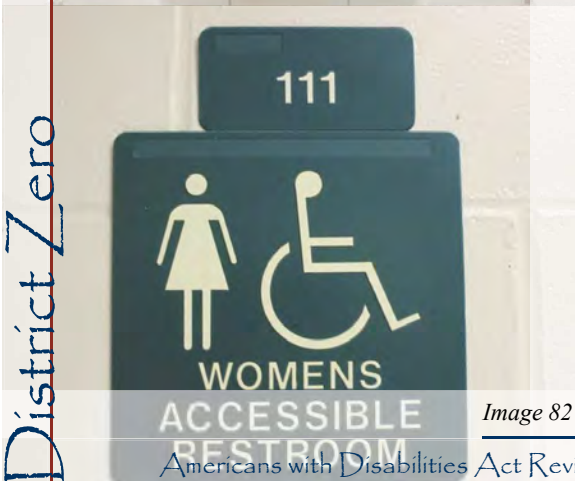
Image 82

- 0-088 Room identification sign mounted above allowed height with braille in wrong location (66-1/2 inches to baseline of room number). Tactile characters on signs shall be located between 48 inches and 60 inches above the finished floor measured from the baseline of the tactile characters. Braille shall be positioned below the corresponding text. [ADA Sections 216 and 703] (See Image 82).

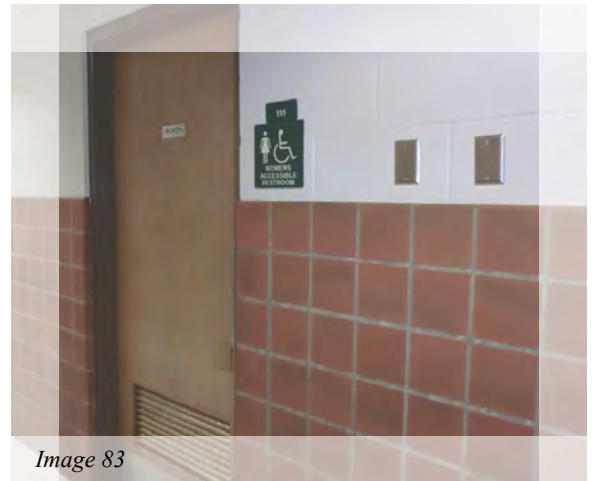
Image 83

- 0-089 No signage directing users to accessible restroom. Where existing toilet rooms do not comply with ADA Design Standards, directional signs indicating the location of the nearest accessible toilet room within the facility shall be provided. [ADA Section 216.8] (See Image 83).

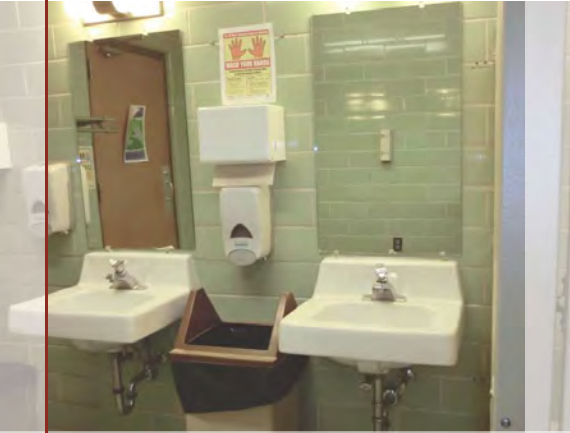
Image 89

- 0-098 No pipe protection provided under lavatory. Water supply and drain pipes under lavatories must be insulated or otherwise configured to protect against contact. [ADA Section 606.5] (See Image 88).

- 0-099 Force to operate lavatory faucet greater than 5 pounds. Operable parts shall be operable with one hand and shall not require tight grasping, pinching, or twisting of the wrist. The force required to activate operable parts shall be 5 pounds maximum. [ADA Sections 309.4 and 606.4] (See Image 88).

» *Recommendations: Wrap pipes of at least one lavatory with insulating material.*

» *Recommendation: Adjust faucet handles of one lavatory to allow for less force required for operation.*

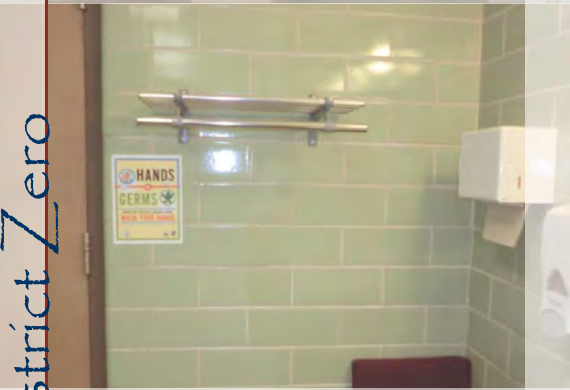
Image 90

- 0-100 Outlet to paper towel dispenser above allowed reach range and blocked by garbage can (52-1/2 inches a.f.f.). Where a clear floor space requires an obstructed parallel approach to an element, the high side reach shall be 46 inches maximum for a reach depth of 24 inches maximum. [ADA Section 308] (See Image 89).

» *Recommendation: Lower paper towel dispenser so that the dispensing outlet is no more than 46 inches above the finished floor.*

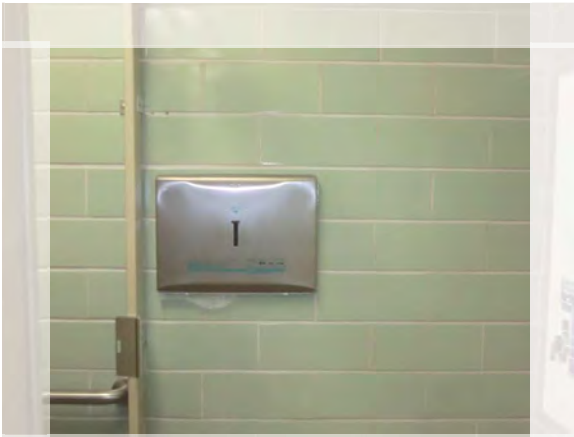
- 0-102 Access to toilet seat cover dispenser above allowed reach range (53-1/4 inches a.f.f.). Where a clear floor space allows an unobstructed approach to an element, the high reach shall be 48 inches maximum, and the low reach shall be 15 inches minimum above the finished floor. [ADA Section 308] (See Image 91 on page 28). ⚓

» *Recommendation: Lower dispenser so that the operating mechanism is no more than 48 inches above the finished floor.*

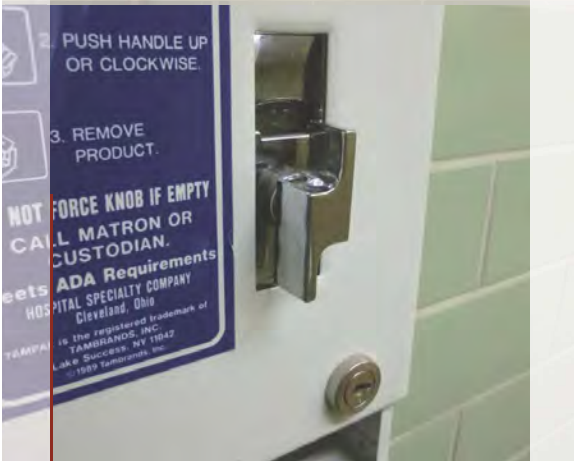
Image 92

- 0-103 Access to tampon/sanitary napkin dispenser above allowed reach range and requires pinching grasp and twisting of wrist to operate. Controls must be within 15 inches to 48 inches above the finished floor and operable with one hand without requiring tight grasping, pinching, or twisting of the wrist. [ADA Section 309.4] (See Image 92).

Replace dispenser with one that does not require twisting.

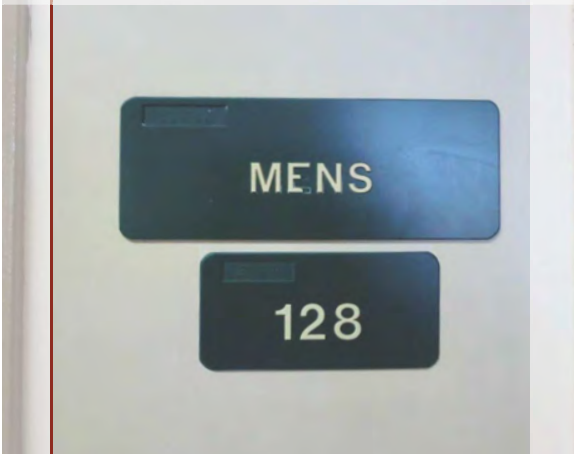
Image 93

- 0-104 Braille on restroom identification sign placed in wrong location. Braille shall be positioned below the corresponding text. [ADA Section 703.3.2] (See Image 93).

» *Recommendation: Replace sign with one that has compliant positioning of braille tactile characters.*

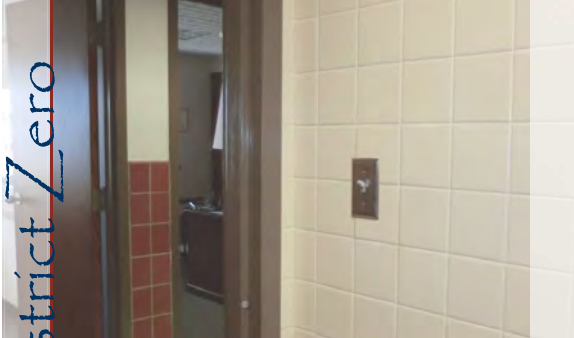
Image 94

- 0-107 Inadequate maneuverability clearance space available on pull side of entrance door (4 inches). Minimum front maneuvering clearance necessary to pull open a door that has a closer is 18 inches. [ADA Section 404.2.4] (See Image 94).

» *Recommendation: Install automatic door opener.*

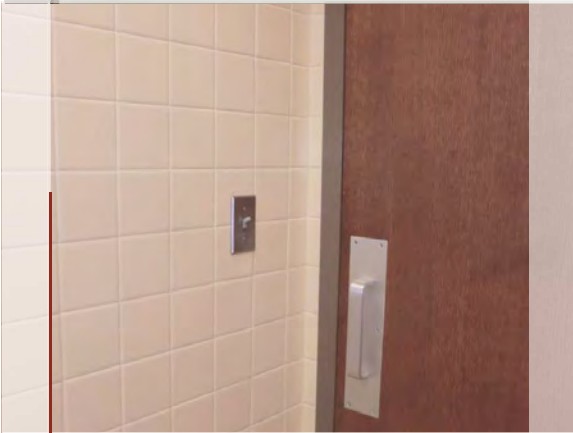
Image 98

- 0-116 Inadequate maneuverability clearance space available on pull side of entrance door (10 inches). Minimum front maneuvering clearance necessary to pull open a door that has a closer is 18 inches. [ADA Section 404.2.4] (See Image 98).

Replace right hand door with left hand door.

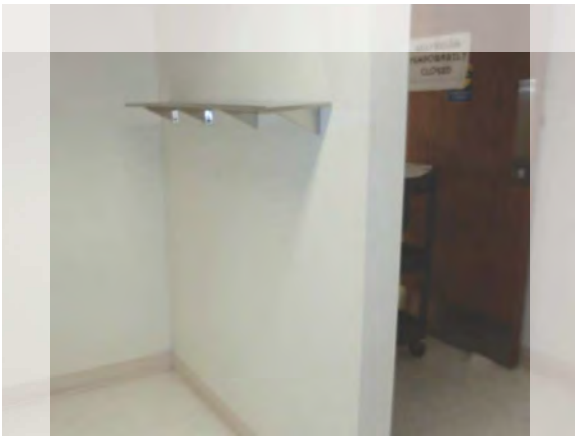
Image 113

- 0-145 Shelf mounted above allowed height and creates protrusion (54 inches a.f.f.). Shelves shall be located 40 inches minimum and 48 inches maximum above the finished floor. Objects with leading edges more than 27 inches and not more than 80 inches above the finished floor shall not protrude more than 4 inches horizontally within the clear floor space. When a cane is used and the element is not in the detectable range, insufficient time is available for the person to detect the element with the cane before there is body contact. [ADA Sections 307.2 and 603.4] (See Image 113). ⚓ for shelf height.

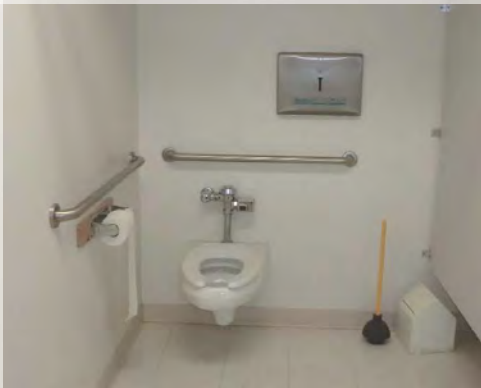
Image 121

- 0-155 Grab bars mounted too high above finished floor (36-7/8 inches a.f.f. - rear/ 36-5/8 inches a.f.f. - side). [ADA Section 609.4] (See Image 121).

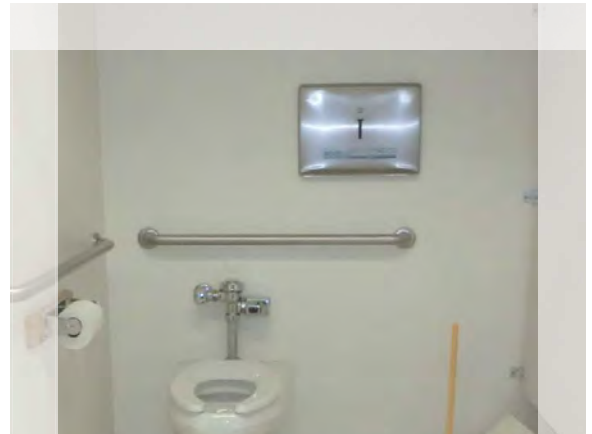
Image 125

- 0-161 Access to toilet seat cover dispenser above allowed reach range (52 inches a.f.f.). Where a clear floor space allows an unobstructed approach to an element, the high reach shall be 48 inches maximum, and the low reach shall be 15 inches minimum above the finished floor. [ADA Section 308] (See Image 125). ⚓

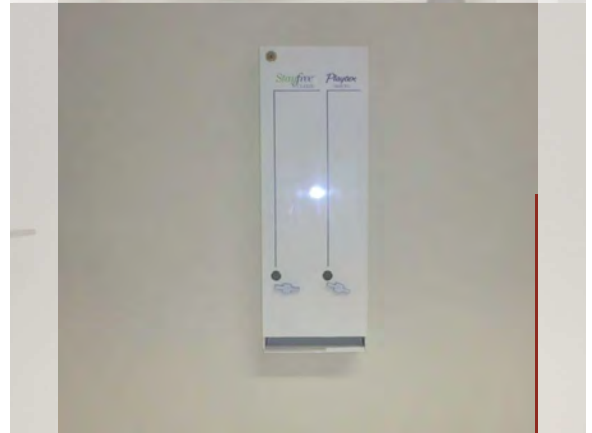
Image 126

- 0-162 Access to tampon/sanitary napkin dispenser above allowed reach range and requires a pinching grasp and twisting of wrist to operate (49-1/2 inches to control mechanism). Controls must be within 15 inches to 48 inches above the finished floor and operable with one hand without requiring tight grasping, pinching, or twisting of the wrist. [ADA Sections 308 and 309.4] (See Image 126).

Mount within compliant reach range. ⚓

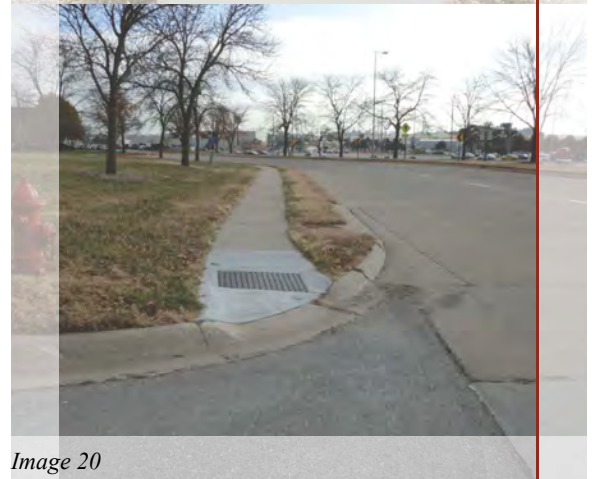
Image 20

- 0-866 Cross slope of curb ramp 1 greater than allowed (8.1%).
 (P5) Cross slope of ramp runs, including curb ramps, shall not be steeper than 1:48 (2%). [ADA Section 405.2] (See Image 20).

- 0-867 No level landing at top of curb ramp 1. Landings with slope and cross slope of 2% or less must be provided at the tops of curb ramps with clear widths at least as wide as the curb ramps, excluding flared sides. [ADA Section 406.4] (See Image 20). ⚓

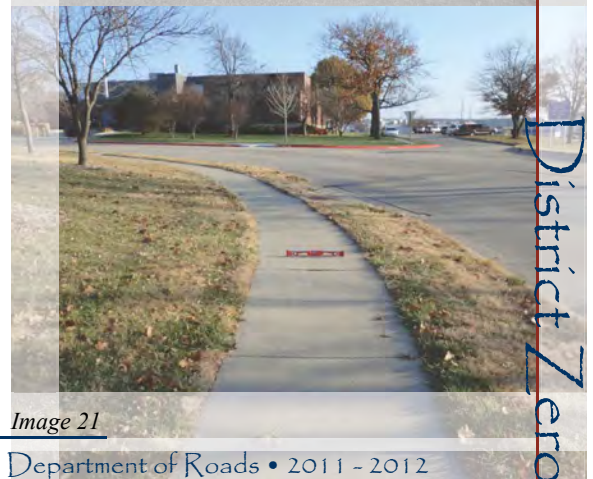
Image 21

- 0-868 Portions of sidewalk from curb ramp 1 to curb ramp 2 have cross slopes out of compliance (2.1% to 4.7%). The cross slope of walking surfaces shall not be steeper than 1:48 (2%). The ADA has determined that a cross slope of greater than 2% can impede forward progress and compromise control and balance. [ADA Section 403.3] (See Image 21).

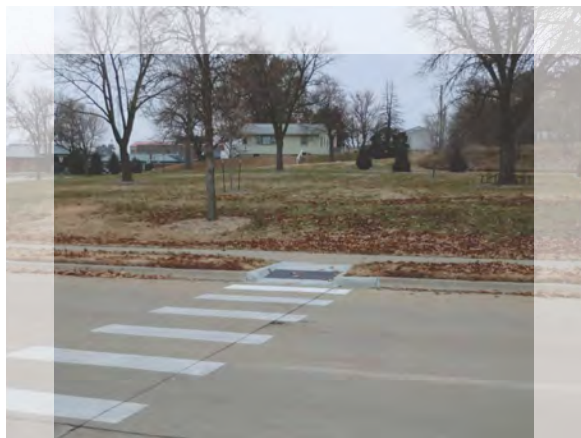
- 0-869 Slope and cross slope of curb ramp 2 greater than allowed (11.2%/2.5%). In existing sites, ramps shall be permitted to have running slopes up to 1:10 (10%) where such slopes are necessary due to space limitations. Otherwise, curb ramps shall have a running slope no steeper than 1:12 (8.33%) and a cross slope of 1:48 (2%) or less. [ADA Sections 405.2 and 405.3] (See Image 22 and recommendation on page 6).

- 0-870 No level landing at top of curb ramp 2. Landings with slopes and cross slopes of 2% or less must be provided at the tops of curb ramps with clear widths at least as wide as the curb ramps, excluding flared sides. [ADA Section 406.4] (See Image 22).

- » *Recommendations: Remove and replace curb ramp so that it meets ADA Design Standards.*

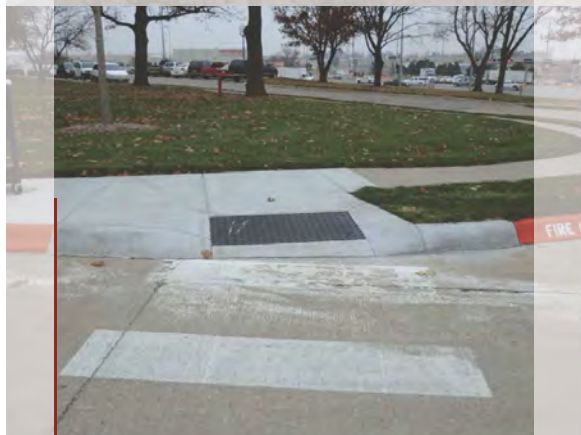
Image 23

- 0-871 Slope of curb ramp 3 greater than allowed (13.2%). In existing sites, ramps shall be permitted to have running slopes up to 1:10 (10%) where such slopes are necessary due to space limitations. Otherwise, curb ramps shall have a running slope no steeper than 1:12 (8.33%). [ADA Section 405.2] (See Image 23).

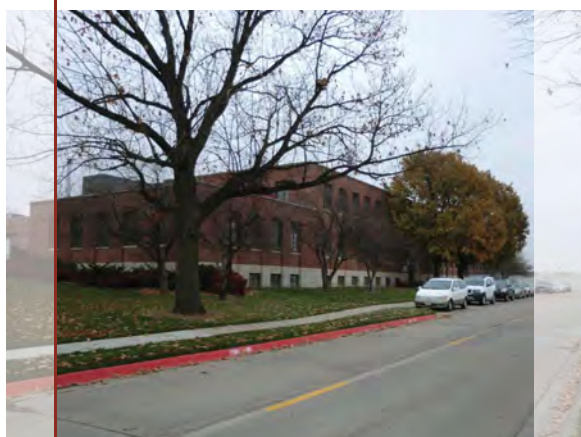
Image 24

- 0-872 Portions of sidewalk from curb ramp 3 to curb ramp 4 have cross slopes out of compliance (2.3% to 4.9%). The cross slope of walking surfaces shall not be steeper than 1:48 (2%). The ADA has determined that a cross slope of greater than 2% can impede forward progress and compromise control and balance. [ADA Section 403.3] (See Image 24).

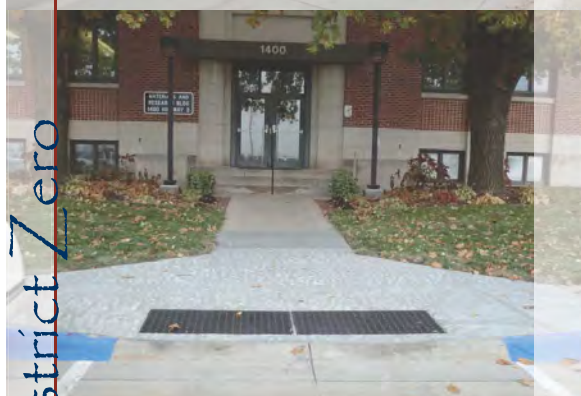
Image 25

- 0-751 Slope of curb ramp 4 (at transition with street) greater than allowed by ADA Design Standards (12.2%). Curb ramp runs shall have a running slope not steeper than 1:12 (8.33%). In existing sites, ramps shall be permitted to have running slopes between 1:10 and 1:12 where such slopes are necessary due to space limitations. [ADA Section 405.2] (See Image 25).

curb ramps with a clear width at least as wide as the curb ramp, excluding flared sides. [ADA Section 406.4] (See Image 25).

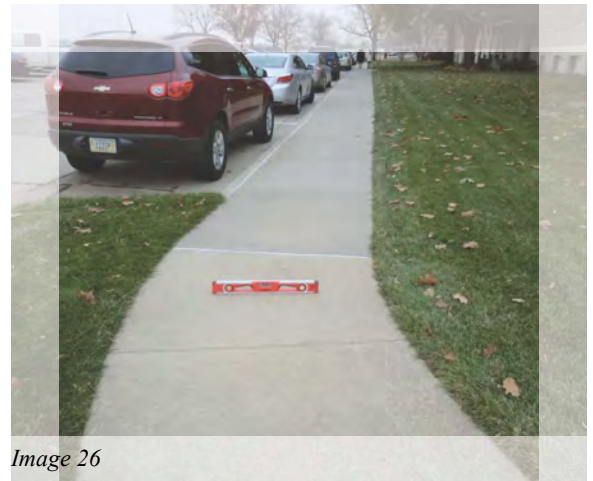
Image 26

Cross slope of accessible route from curb ramp 4 to wheelchair accessible entrance on southeast side of building steeper than allowed by Design Standards (2.1% to 4.4%). The ADA has determined that a cross slope of greater than 1:48 can impede forward progress and compromise control and balance. [ADA Section 403.3] (See Image 26).

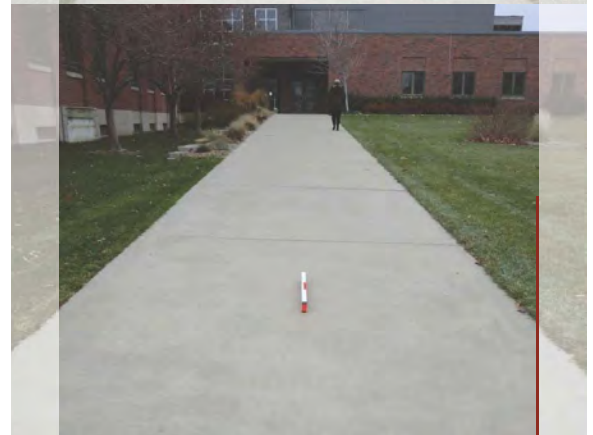
Image 27

Slope of accessible route leading from perimeter sidewalk (along street) to wheelchair accessible entrance on southeast side of building steeper than allowed by Design Standards (5.1% to 6.7%). Any part of an accessible route with a slope greater than 1:20 (5%) shall be considered a ramp and shall comply with design standards regulating ramps. [ADA Sections 303.3 and 405] (See Image 27).

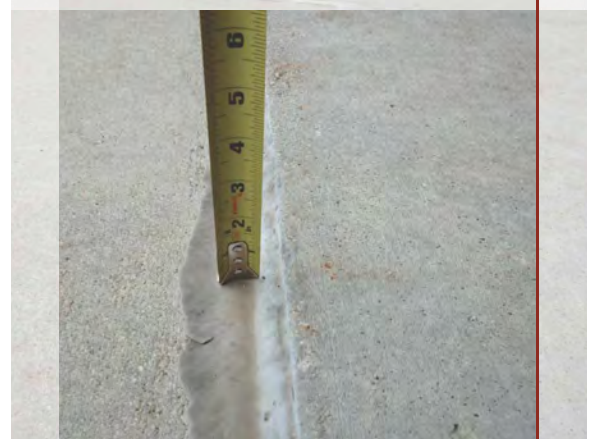
Image 28

Change in level at transition between sloped sidewalk leading to wheelchair accessible entrance on southeast side of building and landing at doors greater than 1/2 inch. Changes in level of 1/4 inch high maximum shall be permitted to be vertical. Changes in level between 1/4 inch high minimum and 1/2 inch high maximum shall be beveled with a slope not steeper than 1:2. [ADA Section 303] (See Image 28).

» *Recommendation: Grind lip and replace caulking to create beveled transition at compliant change in level height.*

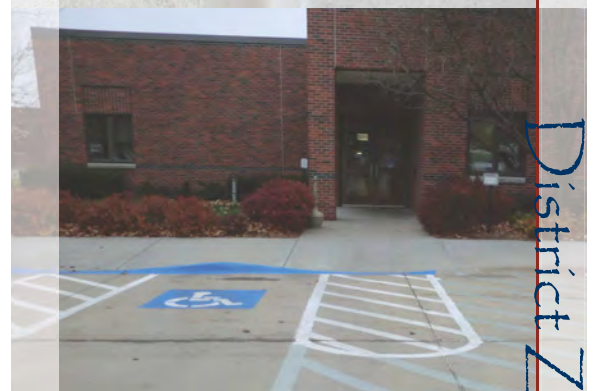
- 0-754 Flared sides of curb ramp 12nw leading to entrance door at rear of building steeper than allowed by ADA Standards (11.7%). Curb ramp flares shall not be steeper than 1:10. [ADA Section 406.3] (See Image 29 on page 7).

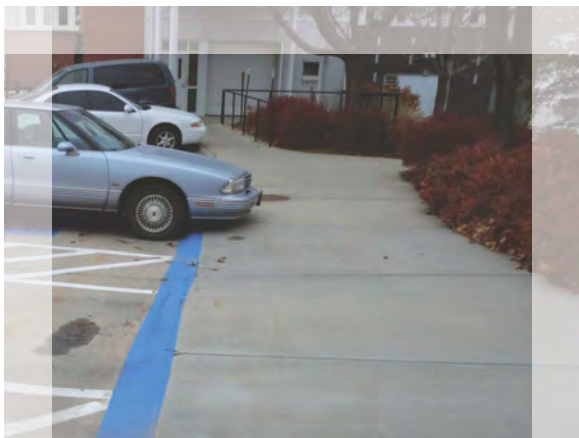
Image 30

- 0-753 No level landing at top of curb ramp 12se at rear of building. Landings must be provided at the tops of curb ramps with a clear width at least as wide as the curb ramp, excluding flared sides. [ADA Section 406.4] (See Image 30).

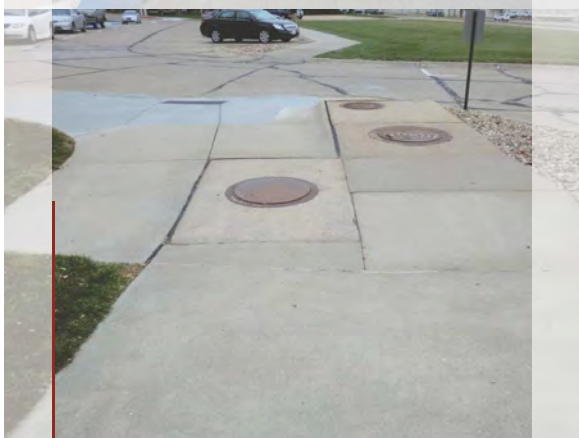
Image 31

- 0-873 No level landing at top of curb ramp 5. Landings must be provided at the tops of curb ramps with a clear width at least as wide as the curb ramp, excluding flared sides. [ADA Section 406.4] (See Image 31).

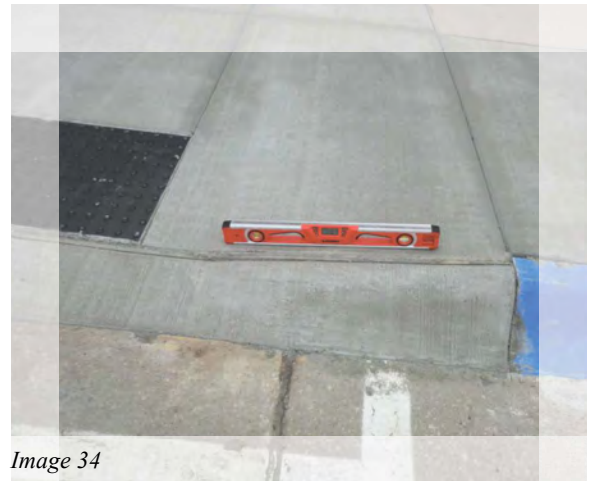
Image 34

- 0-168 Flared sides of curb ramp 6 steeper than allowed by ADA Standards (11.1% and 11.7%). Curb ramp flares shall not be steeper than 1:10 (10%). [ADA Section 406.3] (See Image 34).

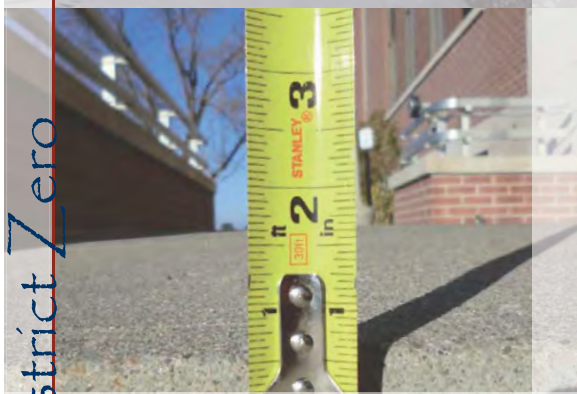
Image 49

- 0-635 Change in level greater than 1/2 inch along both accessible routes to main entrance doors. Changes in level of 1/4 inch high maximum shall be permitted to be vertical. Changes in level between 1/4 inch high minimum and 1/2 inch high maximum shall be beveled with a slope not steeper than 1:2. [ADA Section 303] (See Images 48 and 49).
